# Access Compliance Report Public Rights-of-Way (Curb Ramps)

Main Street: DALE\_ST Cross Street: AUGUSTA\_DR Location: SW

ADA ID: RPAT211130101656 Ramp Type: Type 4 - Parallel Initial Pass/Fail: Fail Overall Compliance: No Severity Score: 2

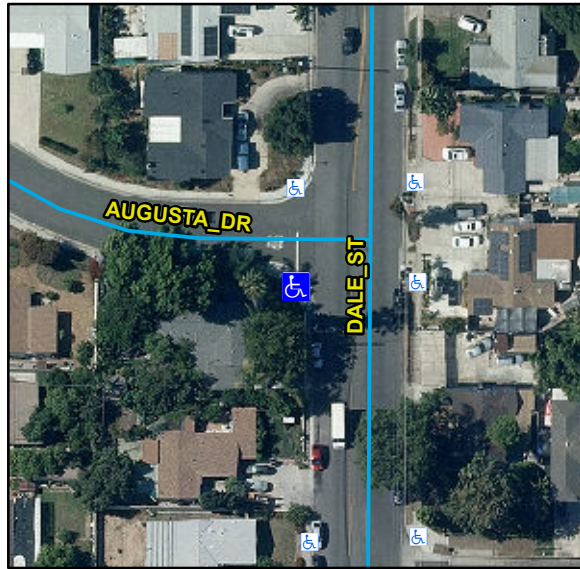
| Compliance | Description | Data | Compliance | Description | Data |
|---|---|---|---|---|---|
| No | Ramp Cross Slope LT (%) | 4.3 | No | Ramp Cross Slope RT (%) | 3.8 |

**Remove & Replace Curb Ramp With Two New Directional Ramps or Equivalent.**

**R304.5.3, STD 1115**
