# Access Compliance Report Public Rights-of-Way (Curb Ramps)

| Main Street: AUGUSTA_DR | | Cross Street: DALE_ST | | Location: | NW |
| ADA ID: RPAT211130102042 | Ramp Type: Type 4 - Parallel | Initial Pass/Fail: Fail | Overall Compliance: No | Severity Score: | 2 |

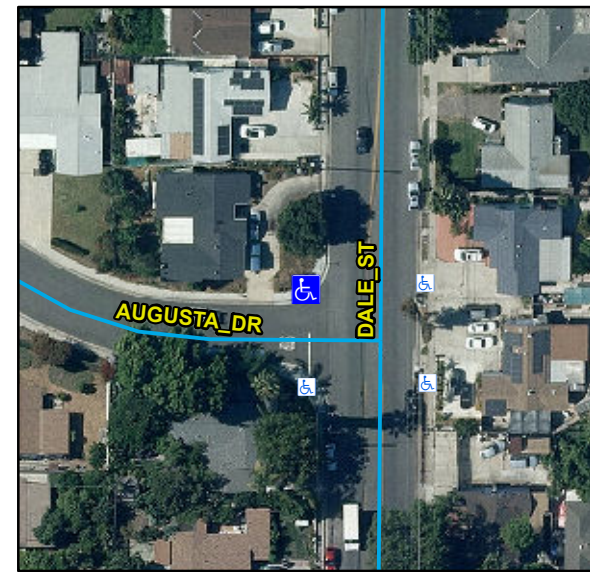
| Compliance | Description | Data | Compliance | Description | Data |
|---|---|---|---|---|---|
| No | Ramp Cross Slope LT (%) | 3.5 | No | Ramp Cross Slope RT (%) | 3.8 |

**Remove & Replace Curb Ramp With Two New Directional Ramps or Equivalent.**

**R304.5.3, STD 1115**

Total Cost: \$ 4000
