# Access Compliance Report Public Rights-of-Way (Curb Ramps)

Main Street: TWANA\_DR Cross Street: DALE\_ST Location: NE

ADA ID: RPAT211130102526 Ramp Type: Type 7 - Directional 2 Initial Pass/Fail: Fail Overall Compliance: No Severity Score: 32

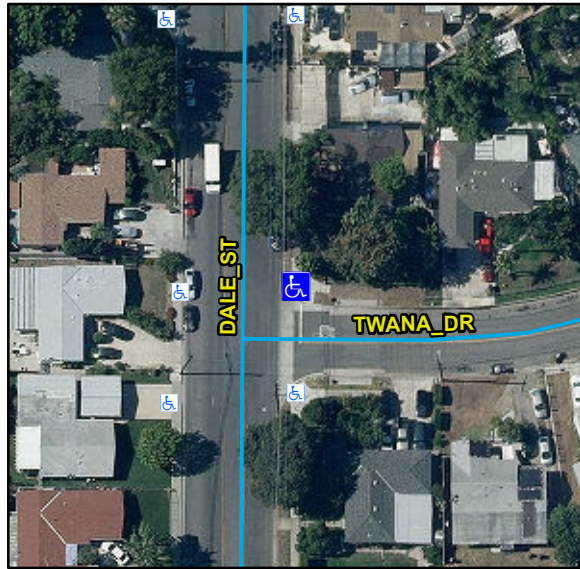
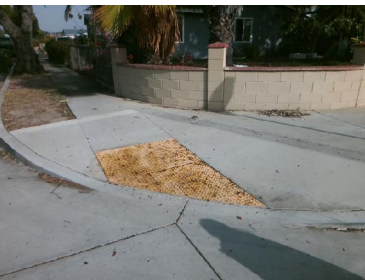
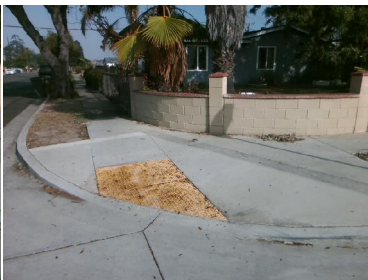
| Compliance | Description | Data | Compliance | Description | Data |
|---|---|---|---|---|---|
| <b>No</b> | Ramp Cross Slope (%) | <b>2.3</b> | <b>N/A</b> | Flare Traversable LT | <b>N/A</b> |

**Remove & Replace Entire Ramp.**

**R304.5.1, R304.5.3, R304.3.2, STD 1115**
