# Access Compliance Report Public Rights-of-Way (Curb Ramps)

| Main Street: CHAPMAN_AVE | | Cross Street: NEARING_DR | | Location: | NW |
| ADA ID: RPAT211130120058 | Ramp Type: Type 4 - Parallel | Initial Pass/Fail: Fail | Overall Compliance: No | Severity Score: | 15 |

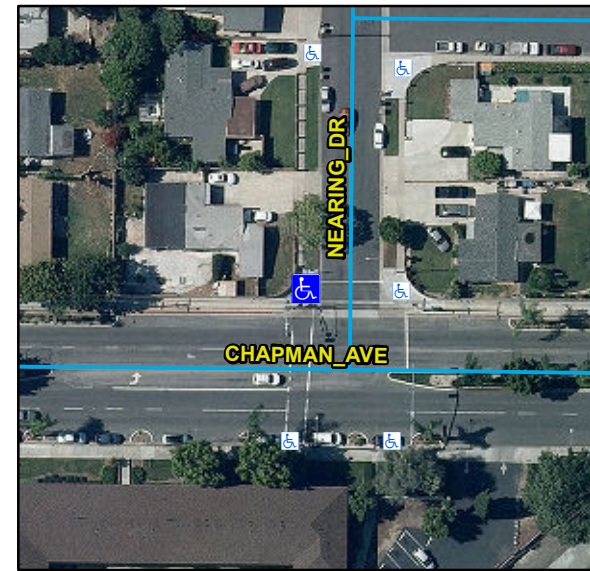
| Compliance | Description | Data | Compliance | Description | Data |
|---|---|---|---|---|---|
| No | Ramp Cross Slope LT (%) | 6.1 | No | Ramp Cross Slope RT (%) | 5.7 |
| N/A | Gutter Ponding | N/A | No | Curb Slope | 15.3 |

**Remove & Replace Curb Ramp With Two New Directional Ramps or Equivalent.**

**R304.2.2, R304.5.3, STD 1115**

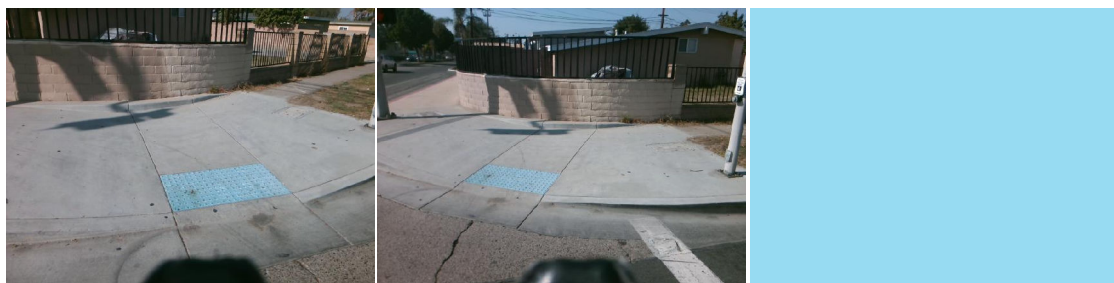
| Compliance | Description | Data | Compliance | Description | Data |
|---|---|---|---|---|---|
| N/A | Ramp Length LT (in) | 96 | N/A | Ramp Length RT (in) | 133 |
| Yes | Ramp Width LT (in) | 106 | Yes | Ramp Width RT (in) | 106 |
| Yes | Ramp Run Slope LT (%) | 3.6 | Yes | Ramp Run Slope RT (%) | 4.7 |
