# Access Compliance Report Public Rights-of-Way (Curb Ramps)

Main Street: CHAPMAN\_AVE Cross Street: NEARING\_DR Location: S

ADA ID: RPAT211130120705 Ramp Type: Type 4 - Parallel Initial Pass/Fail: Fail Overall Compliance: No Severity Score: 2

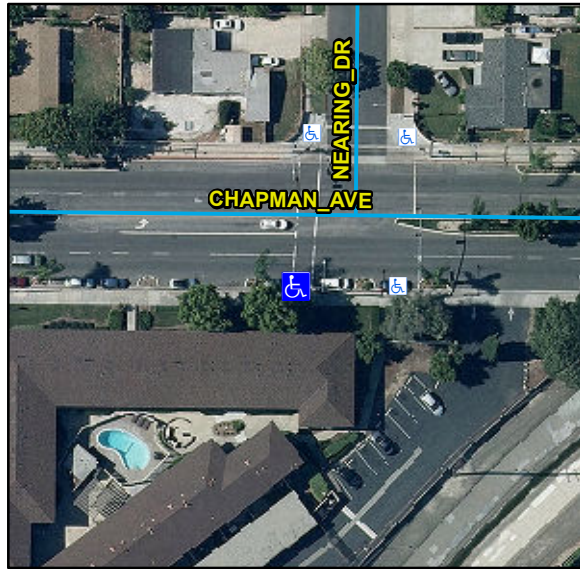
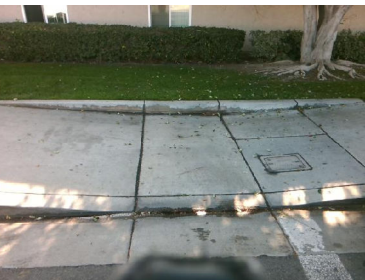
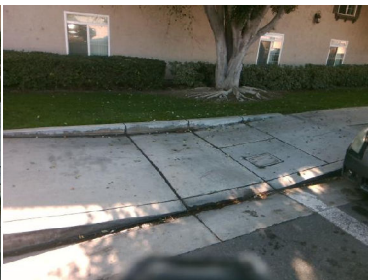
| Compliance | Description | Data | Compliance | Description | Data |
|---|---|---|---|---|---|
| No | Ramp Cross Slope LT (%) | 4.5 | No | Ramp Cross Slope RT (%) | 2.3 |

Remove & Replace Entire Ramp.

R304.5.3, STD 1115
