# Access Compliance Report Public Rights-of-Way (Curb Ramps)

Main Street: BEACH\_BLVD Cross Street: CHAPMAN\_AVE Location: SW

ADA ID: RPAT211130123143 Ramp Type: Type 4 - Parallel Initial Pass/Fail: Fail Overall Compliance: No Severity Score: 15

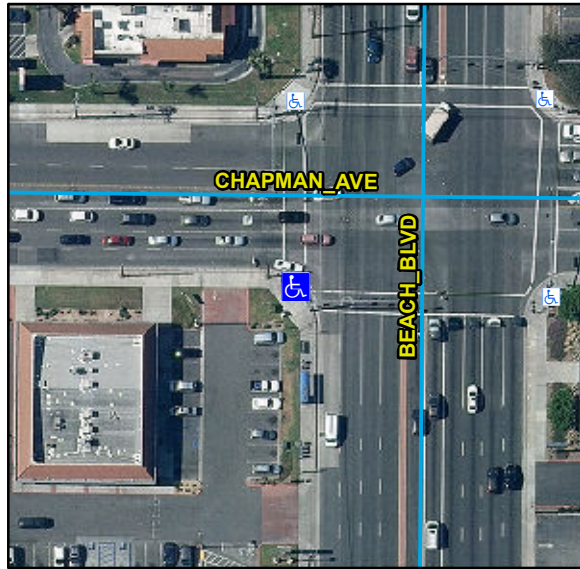
| Compliance | Description | Data | Compliance | Description | Data |
|---|---|---|---|---|---|
| No | Ramp Cross Slope LT (%) | 6 | Yes | Ramp Cross Slope RT (%) | 0.7 |

Remove & Replace Curb Ramp With Two New Directional Ramps or Equivalent.

R304.5.3, STD 1115

Total Cost: \$ 4000
