# Access Compliance Report Public Rights-of-Way (Curb Ramps)

Main Street: **MARIAN\_AVE** Cross Street: **THISTLE\_RD** Location: **NE**

ADA ID: **RPAT211130132010** Ramp Type: **Type 6 - Directional 1** Initial Pass/Fail: **Fail** Overall Compliance: **No** Severity Score: **0**

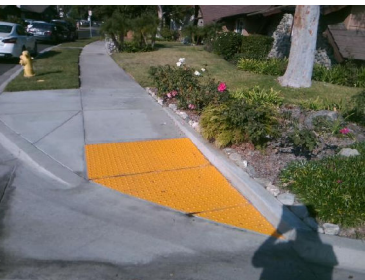
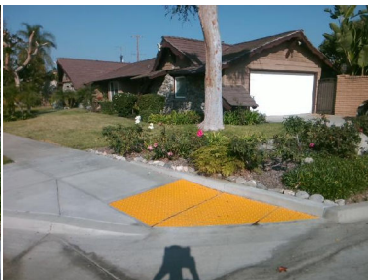
| Compliance | Description | Data | Compliance | Description | Data |
|---|---|---|---|---|---|
| <b>Yes</b> | Overall Surface Condition | <b>Acceptable</b> | <b>Yes</b> | Perp Joint Present | <b>Yes</b> |
