# Access Compliance Report Public Rights-of-Way (Curb Ramps)

Main Street: RAMM\_DR Cross Street: THISTLE\_RD Location: N

ADA ID: RPAT211130134552 Ramp Type: Type 6 - Directional 1 Initial Pass/Fail: Fail Overall Compliance: No Severity Score: 2

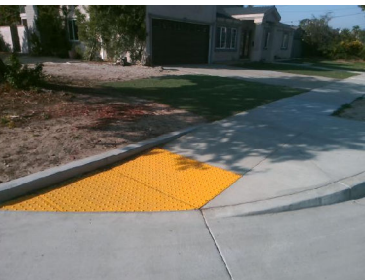
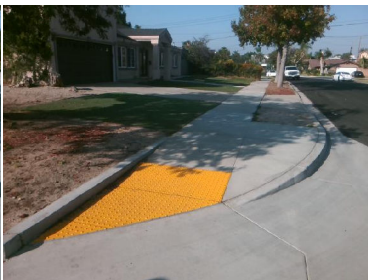
| Compliance | Description | Data | Compliance | Description | Data |
|---|---|---|---|---|---|
| Yes | Overall Surface Condition | Acceptable | Yes | Perp Joint Present | Yes |
