# Access Compliance Report Public Rights-of-Way (Curb Ramps)

Main Street: ORANGE\_AVE Cross Street: THISTLE\_RD Location: NW

ADA ID: RPAT211130140832 Ramp Type: Type 1 - Perpendicular Diagonal Initial Pass/Fail: Pass Overall Compliance: No Severity Score: 0

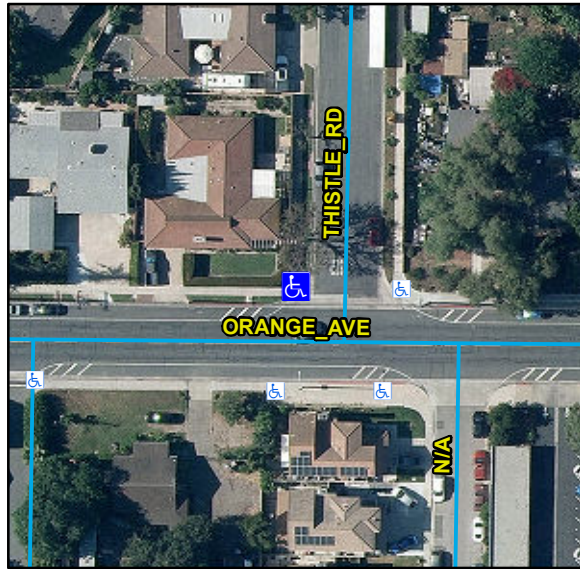
| Compliance | Description | Data | Compliance | Description | Data |
|---|---|---|---|---|---|
| N/A | Landing Length (in) | 48 | | | Sloped |
| N/A | Landing Movement Obstructed? | Yes | Yes | DWS Contrast | Yes |

Remove & Replace Landing.

R304.2.1, STD 1115
