# Access Compliance Report

### (Curb Ramps)

Main Street: THISTLE\_RD Cross Street: ORANGE\_AVE Location: NE

ADA ID: RPAT211130141331 Ramp Type: Type 4 - Parallel Initial Pass/Fail: Pass Overall Compliance: No Severity Score: 6

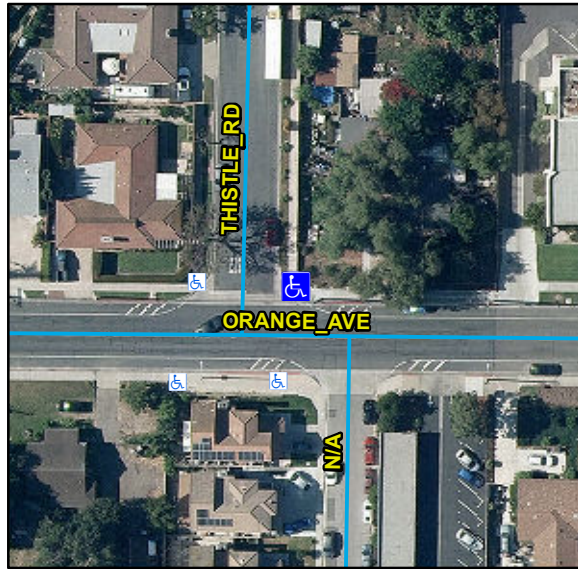
| Compliance | Description | Data | Compliance | Description | Data |
|---|---|---|---|---|---|
| No | Gutter Run Slope (%) | 6.7 | | Road Cross Slope (%) | 2 |

Possible Solutions:

Remove & Replace Gutter.

R304.5.4, STD 1115

Total Cost: \$ 252
