# Access Compliance Report Public Rights-of-Way (Curb Ramps)

Main Street: HILLVIEW\_RD Cross Street: ORANGE\_AVE Location: NE

ADA ID: RPAT211130143941 Ramp Type: Type 4 - Parallel Initial Pass/Fail: Fail Overall Compliance: No Severity Score: 15

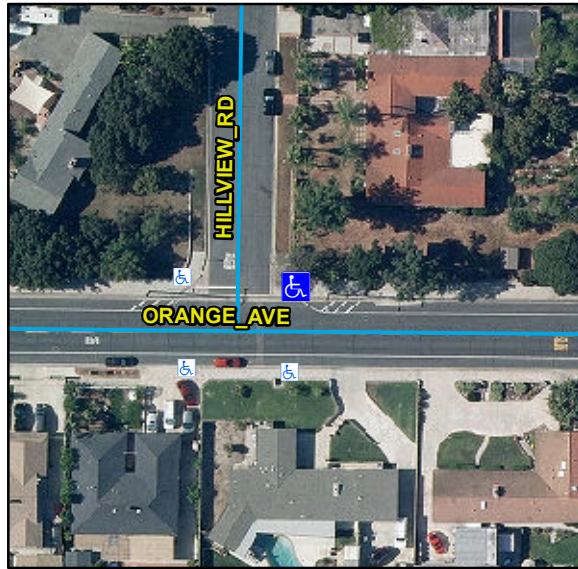
| Compliance | Description | Data | Compliance | Description | Data |
|---|---|---|---|---|---|
| No | Ramp Cross Slope LT (%) | 3.4 | No | Ramp Cross Slope RT (%) | 6 |

**Remove & Replace Curb Ramp With Two New Directional Ramps or Equivalent.**

**R304.5.3, STD 1115**

Total Cost: \$ 4000
