# Access Compliance Report Public Rights-of-Way (Curb Ramps)

Main Street: CHESNEY\_DR Cross Street: FOSTER\_RD Location: NE

ADA ID: RPAT211201083653 Ramp Type: Type 1 - Perpendicular Diagonal Initial Pass/Fail: Pass Overall Compliance: No Severity Score: 14

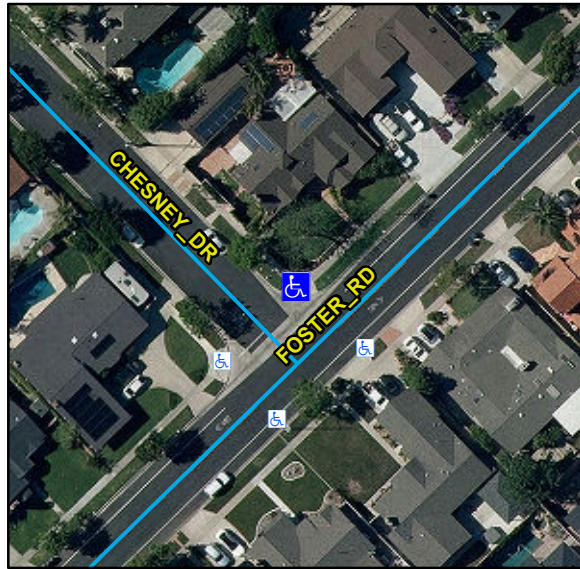
| Compliance | Description | Data | Compliance | Description | Data |
|---|---|---|---|---|---|
| No | Landing Run Slope (%) | 2.1 | N/A | Flare Traversable RT | No |
| Yes | Landing Cross Slope (%) | 0.8 | No | DWS Provided | No |
| Yes | Gutter Ponding | No | No | Curb Slope | 9.3 |

Remove & Replace Curb Ramp With Two New Directional Ramps or Equivalent.

R304.2.2, R204.3, R304.2.1, R304.2.2-Perp, R304.3.2-Para, R305, STD 1115
