# Access Compliance Report Public Rights-of-Way (Curb Ramps)

Main Street: CHESNEY\_DR Cross Street: LOCH\_LOMOND\_RD Location: NE

ADA ID: RPAT211201084637 Ramp Type: Type 1 - Perpendicular Diagonal Initial Pass/Fail: Fail Overall Compliance: No Severity Score: 16

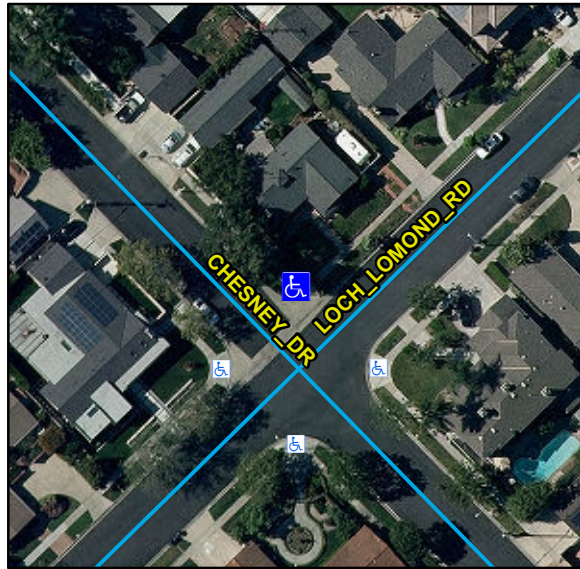
| Compliance | Description | Data | Compliance | Description | Data |
|---|---|---|---|---|---|
| No | Ramp Run Slope (%) | 9 | N/A | Flare Slope LT (%) | N/A |
| No | Ramp Cross Slope (%) | 2.4 | N/A | Flare Traversable LT | N/A |

Remove & Replace Curb Ramp With Two New Directional Ramps or Equivalent.

R304.2.2, R204.3, R304.5.3, STD 1115
