# Access Compliance Report Public Rights-of-Way (Curb Ramps)

Main Street: CHESNEY\_DR Cross Street: WEMBLEY\_RD Location: SW

ADA ID: RPAT211201085905 Ramp Type: Type 1 - Perpendicular Diagonal Initial Pass/Fail: Fail Overall Compliance: No Severity Score: 16

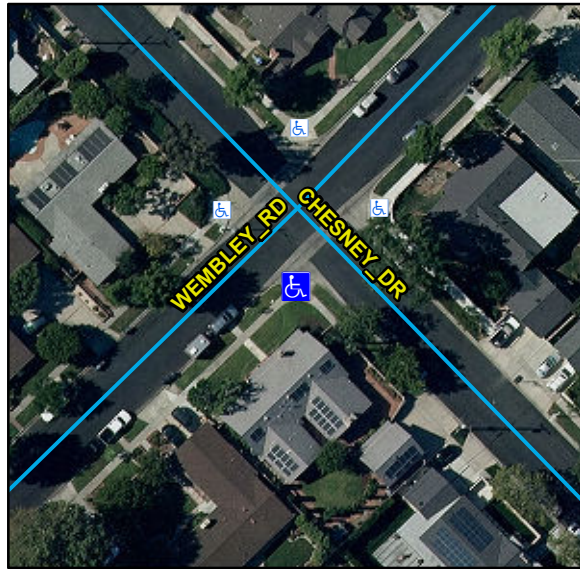
| Compliance | Description | Data | Compliance | Description | Data |
|---|---|---|---|---|---|
| No | Ramp Run Slope (%) | 8.4 | N/A | Flare Slope LT (%) | N/A |

Remove & Replace Curb Ramp With Two New Directional Ramps or Equivalent.

R204.3, R304.2.2, STD 1115
