# Access Compliance Report Public Rights-of-Way (Curb Ramps)

Main Street: WEMBLEY\_RD Cross Street: CHESNEY\_DR Location: W

ADA ID: RPAT211201090206 Ramp Type: Type 1 - Perpendicular Diagonal Initial Pass/Fail: Fail Overall Compliance: No Severity Score: 15

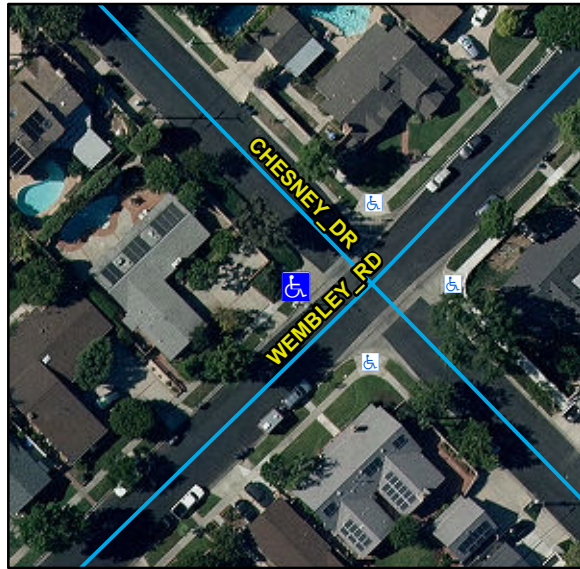
R304.2.2, R204.3, STD 1115

| Compliance | Description | Data | Compliance | Description | Data |
|---|---|---|---|---|---|
| No | Ramp Run Slope (%) | 8.6 | N/A | Flare Slope LT (%) | N/A |

Remove & Replace Curb Ramp With Two New Directional Ramps or Equivalent.
