# Access Compliance Report Public Rights-of-Way (Curb Ramps)

Main Street: CHESNEY\_DR Cross Street: WEMBLEY\_RD Location: N

ADA ID: RPAT211201090505 Ramp Type: Type 1 - Perpendicular Diagonal Initial Pass/Fail: Pass Overall Compliance: No Severity Score: 14

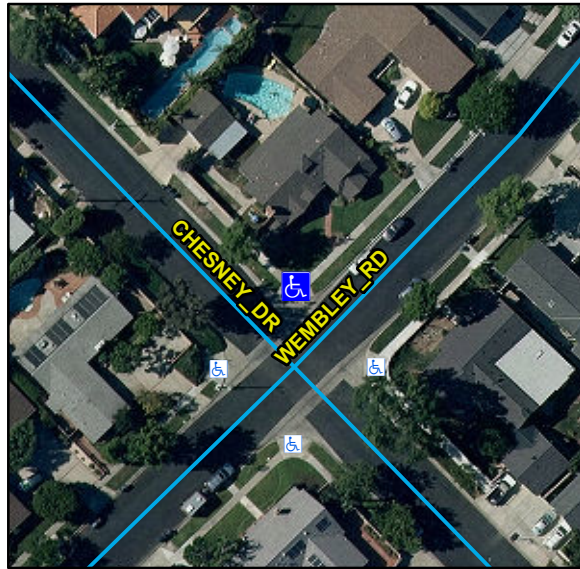
| Compliance | Description | Data | Compliance | Description | Data |
|---|---|---|---|---|---|
| N/A | Ramp Length (in) | 82 | N/A | Flare Type LT | |
| Yes | Ramp Width (in) | 50 | | | Sloped |
| Yes | Ramp Run Slope (%) | 7.7 | N/A | Flare Slope LT (%) | 9.3 |
| Yes | Ramp Cross Slope (%) | 0.6 | N/A | Flare Traversable LT | No |
| No | Landing Run Slope (%) | 2.7 | N/A | Flare Traversable RT | No |
| Yes | Landing Cross Slope (%) | 0.5 | No | DWS Provided | No |

Remove & Replace Curb Ramp With Two New Directional Ramps or Equivalent.

R204.3, R304.2.1, R304.2.2-Perp, R304.3.2-Para, R305, STD 1115

Total Cost: \$ 6160
