# Access Compliance Report Public Rights-of-Way (Curb Ramps)

Main Street: KENSINGTON\_RD Cross Street: CHESNEY\_DR Location: SE

ADA ID: RPAT211201091348 Ramp Type: Type 1 - Perpendicular Diagonal Initial Pass/Fail: Fail Overall Compliance: No Severity Score: 15

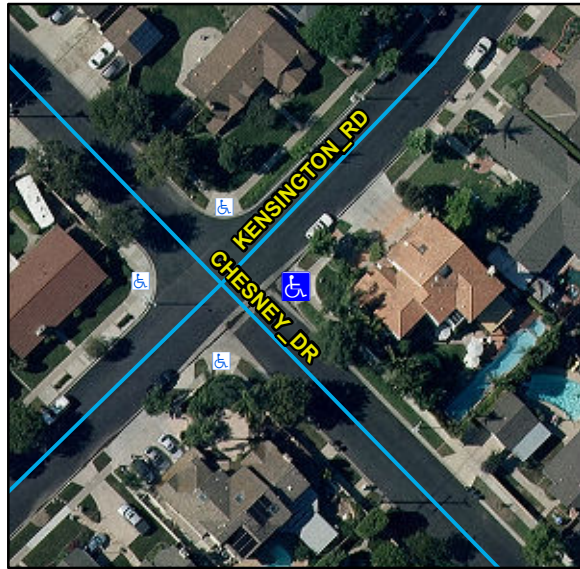
| Compliance | Description | Data | Compliance | Description | Data |
|---|---|---|---|---|---|
| No | Ramp Run Slope (%) | 8.6 | N/A | Flare Slope LT (%) | N/A |

Remove & Replace Curb Ramp With Two New Directional Ramps or Equivalent.
