# Access Compliance Report Public Rights-of-Way (Curb Ramps)

Main Street: KENSINGTON\_RD Cross Street: CHESNEY\_DR Location: W

ADA ID: RPAT211201092031 Ramp Type: Type 1 - Perpendicular Diagonal Initial Pass/Fail: Fail Overall Compliance: No Severity Score: 15

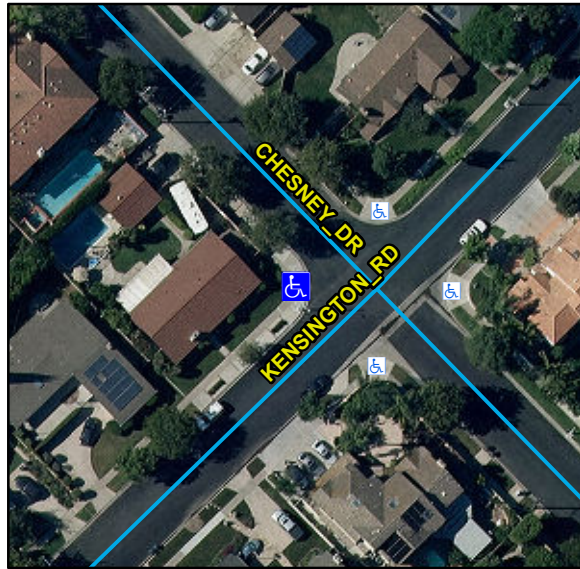
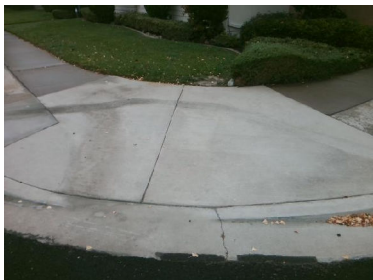
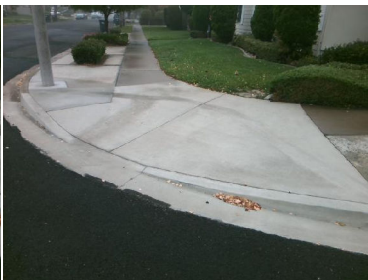
| Compliance | Description | Data | Compliance | Description | Data |
|---|---|---|---|---|---|
| No | Ramp Run Slope (%) | 8.5 | N/A | Flare Slope LT (%) | N/A |

Remove & Replace Curb Ramp With Two New Directional Ramps or Equivalent.

R204.3, R304.2.2, STD 1115
