# Access Compliance Report Public Rights-of-Way (Curb Ramps)

| Main Street: SHAKESPEARE_DR | | Cross Street: WEMBLEY_RD | | Location: | S |
| ADA ID: RPAT211201100657 | Ramp Type:Type 1 - Perpendicular Diagonal Initial Pass/Fail: Fail | | Overall Compliance: No | Severity Score: | 15 |

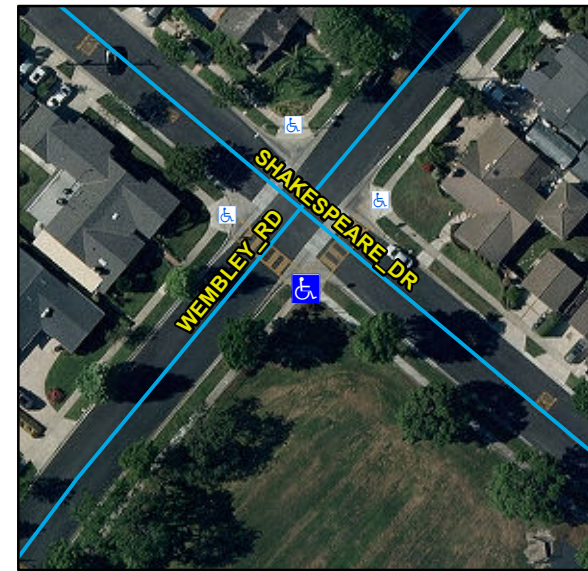
| Compliance | Description | Data | Compliance | Description | Data |
|---|---|---|---|---|---|
| No | Ramp Run Slope (%) | 8.4 | N/A | Flare Slope LT (%) | N/A |

**Remove & Replace Curb Ramp With Two New Directional Ramps or Equivalent.**

**R204.3, R304.2.2, STD 1115**
