# Access Compliance Report Public Rights-of-Way (Curb Ramps)

| Main Street: WEMBLEY_RD | | Cross Street: SHAKESPEARE_DR | | Location: | E |
| ADA ID: RPAT211201100954 | Ramp Type:Type 1 - Perpendicular Diagonal Initial Pass/Fail: Fail | | Overall Compliance: No | Severity Score: | 16 |

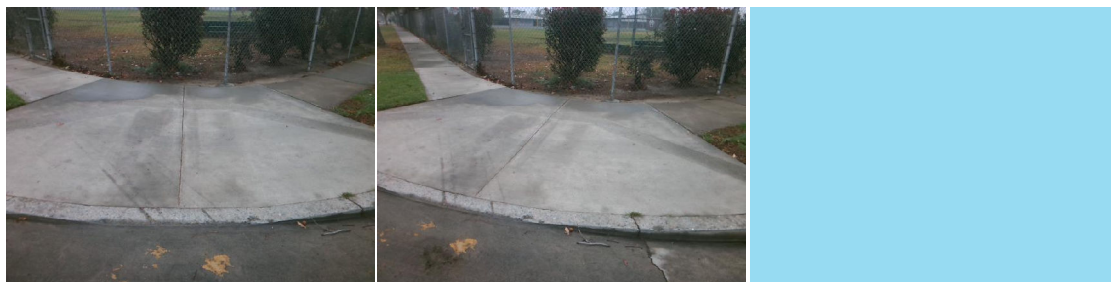
| Compliance | Description | Data | Compliance | Description | Data |
|---|---|---|---|---|---|
| No | Ramp Run Slope (%) | 8.9 | N/A | Flare Slope LT (%) | N/A |
| No | Ramp Cross Slope (%) | 3.7 | N/A | Flare Traversable LT | N/A |
| N/A | Gutter Ponding | N/A | No | Curb Slope | 13 |

**Remove & Replace Curb Ramp With Two New Directional Ramps or Equivalent.**
