# Access Compliance Report Public Rights-of-Way (Curb Ramps)

Main Street: WEMBLEY\_RD Cross Street: SHAKESPEARE\_DR Location: W

ADA ID: RPAT211201101348 Ramp Type: Type 1 - Perpendicular Diagonal Initial Pass/Fail: Fail Overall Compliance: No Severity Score: 2

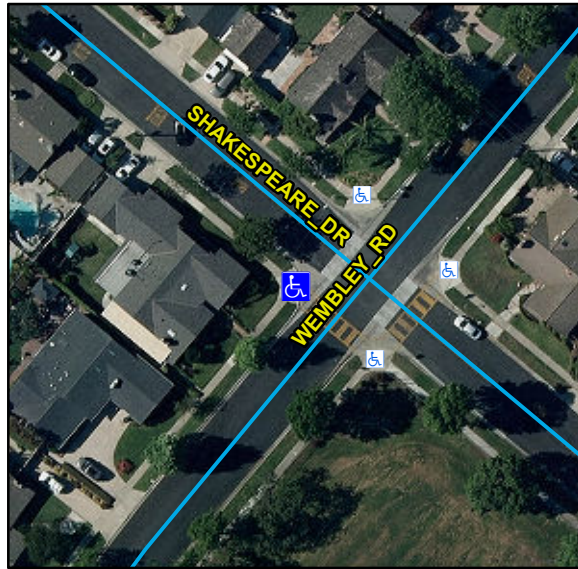
| Compliance | Description | Data | Compliance | Description | Data |
|---|---|---|---|---|---|
| No | Ramp Cross Slope (%) | 2.7 | N/A | Flare Traversable LT | N/A |

Remove & Replace Curb Ramp With Two New Directional Ramps or Equivalent.

R204.3, R304.5.3, STD 1115
