# Access Compliance Report Public Rights-of-Way (Curb Ramps)

Main Street: KENSINGTON\_RD Cross Street: SHAKESPEARE\_DR Location: E

ADA ID: RPAT211201102113 Ramp Type: Type 1 - Perpendicular Diagonal Initial Pass/Fail: Fail Overall Compliance: No Severity Score: 16

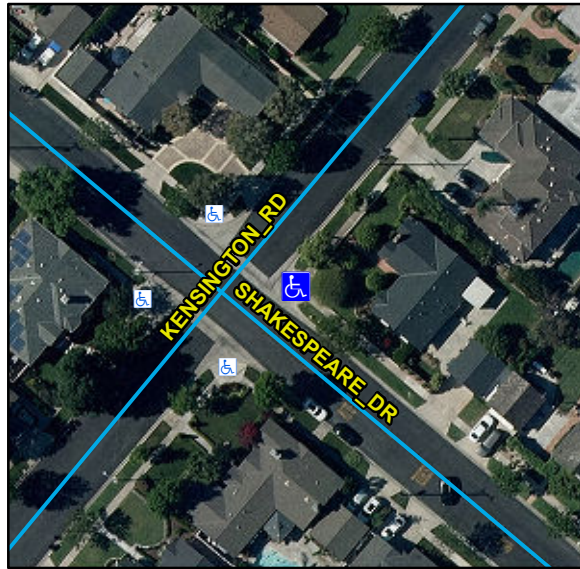
| Compliance | Description | Data | Compliance | Description | Data |
|---|---|---|---|---|---|
| No | Ramp Run Slope (%) | 9.3 | N/A | Flare Slope LT (%) | N/A |
| No | Ramp Cross Slope (%) | 3.5 | N/A | Flare Traversable LT | N/A |

Remove & Replace Curb Ramp With Two New Directional Ramps or Equivalent.
