# Access Compliance Report Public Rights-of-Way (Curb Ramps)

| Main Street: SHAKESPEARE_DR | | Cross Street: KENSINGTON_RD | | Location: | N |
| ADA ID: RPAT211201102527 | Ramp Type:Type 1 - Perpendicular Diagonal Initial Pass/Fail: Fail | | Overall Compliance: No | Severity Score: | 15 |

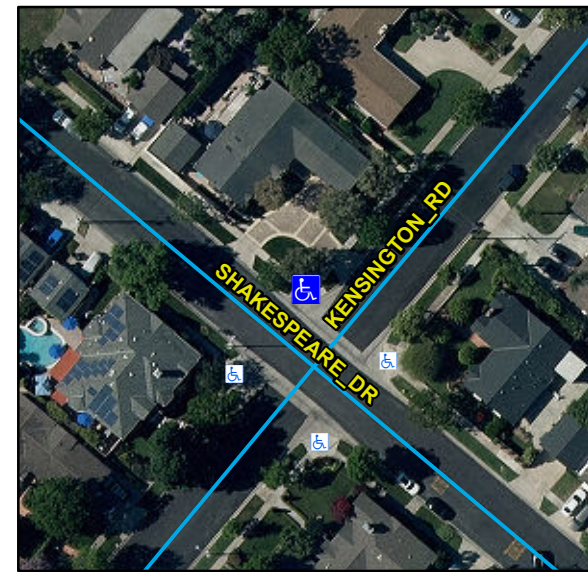
| Compliance | Description | Data | Compliance | Description | Data |
|---|---|---|---|---|---|
| No | Ramp Run Slope (%) | 9.4 | N/A | Flare Slope LT (%) | N/A |

**Remove & Replace Curb Ramp With Two New Directional Ramps or Equivalent.**

**R204.3, R304.2.2, STD 1115**
