# Access Compliance Report Public Rights-of-Way (Curb Ramps)

| Main Street: KENSINGTON_RD | | Cross Street: SHAKESPEARE_DR | | Location: | W |
| ADA ID: RPAT211201102752 | Ramp Type:Type 1 - Perpendicular Diagonal Initial Pass/Fail: Pass | | Overall Compliance: No | Severity Score: | 14 |

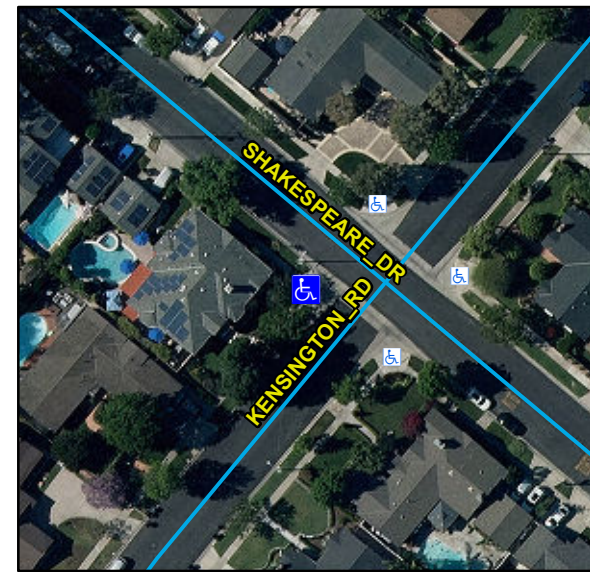
| Compliance | Description | Data | Compliance | Description | Data |
|---|---|---|---|---|---|
| Yes | Landing Cross Slope (%) | 2.7 | No | DWS Provided | No |
| Yes | Gutter Ponding | No | No | Curb Slope | 6 |

Remove & Replace Curb Ramp With Two New Directional Ramps or Equivalent.

R304.2.2, R204.3, R304.2.1, R305, STD 1115

Total Cost: \$ 6160
