# Access Compliance Report Public Rights-of-Way (Curb Ramps)

| Main Street: SHAKESPEARE_DR | | Cross Street: KENSINGTON_RD | | Location: | SW |
| ADA ID: RPAT211201103303 | Ramp Type:Type 1 - Perpendicular Diagonal Initial Pass/Fail: Fail | | Overall Compliance: No | Severity Score: | 16 |

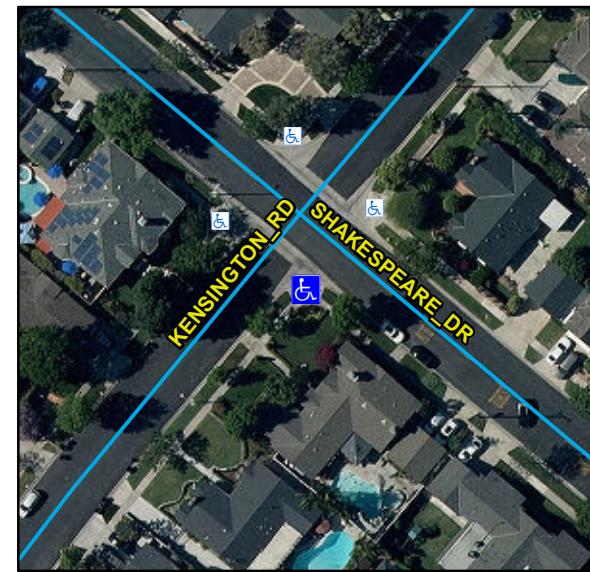
| Compliance | Description | Data | Compliance | Description | Data |
|---|---|---|---|---|---|
| No | Ramp Run Slope (%) | 8.4 | N/A | Flare Slope LT (%) | N/A |

**Remove & Replace Curb Ramp With Two New Directional Ramps or Equivalent.**

**R304.2.2, R204.3, STD 1115**
