# Access Compliance Report Public Rights-of-Way (Curb Ramps)

Main Street: SHAKESPEARE\_DR Cross Street: MARTHA\_ANN\_DR Location: S

ADA ID: RPAT211201103657 Ramp Type: Type 1 - Perpendicular Diagonal Initial Pass/Fail: Fail Overall Compliance: No Severity Score: 15

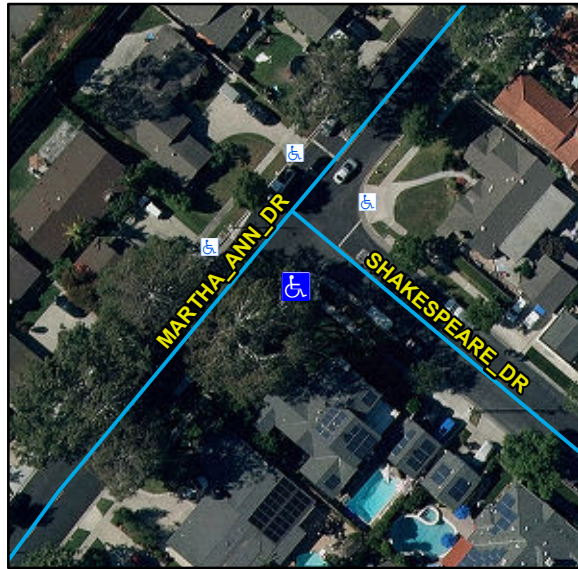
| Compliance | Description | Data | Compliance | Description | Data |
|---|---|---|---|---|---|
| No | Ramp Run Slope (%) | 9.2 | N/A | Flare Slope LT (%) | N/A |

**Remove & Replace Curb Ramp With Two New Directional Ramps or Equivalent.**
