# Access Compliance Report Public Rights-of-Way (Curb Ramps)

Main Street: MARTHA\_ANN\_DR Cross Street: SILVERWOOD\_DR Location: E

ADA ID: RPAT211201104950 Ramp Type: Type 1 - Perpendicular Diagonal Initial Pass/Fail: Fail Overall Compliance: No Severity Score: 2

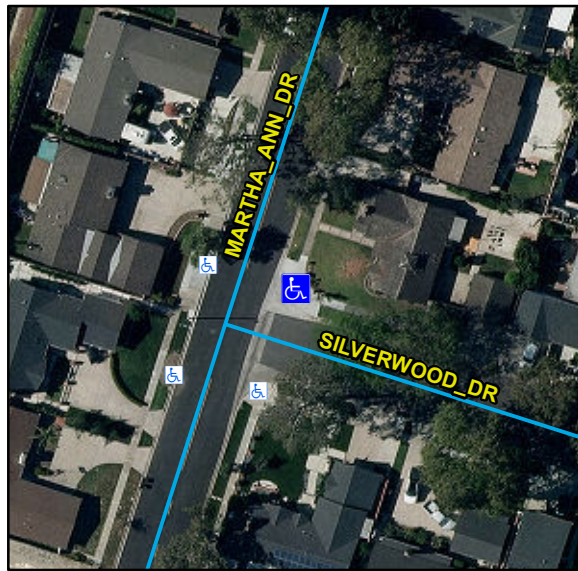
| Compliance | Description | Data | Compliance | Description | Data |
|---|---|---|---|---|---|
| No | Ramp Cross Slope (%) | 2.3 | N/A | Flare Traversable LT | N/A |

Remove & Replace Curb Ramp With Two New Directional Ramps or Equivalent.

R304.5.3, STD 1115
