# Access Compliance Report Public Rights-of-Way (Curb Ramps)

Main Street: MARTHA\_ANN\_DR Cross Street: SILVERWOOD\_DR Location: N

ADA ID: RPAT211201105229 Ramp Type: Type 1 - Perpendicular Initial Pass/Fail: Pass Overall Compliance: No Severity Score: 9

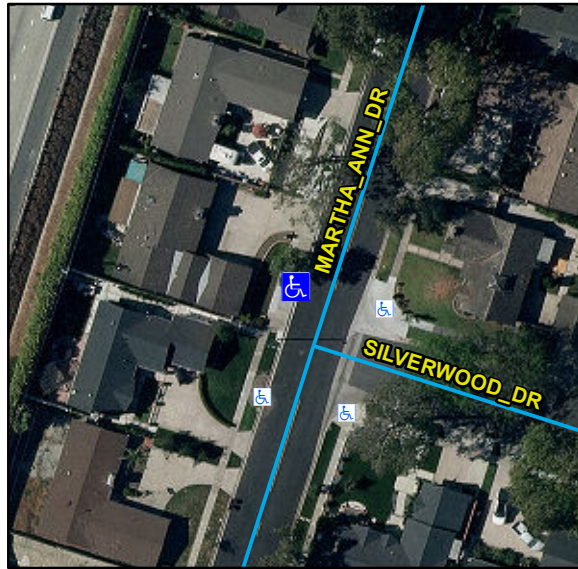
| Compliance | Description | Data | Compliance | Description | Data |
|---|---|---|---|---|---|
| Yes | Gutter Ponding | No | No | Curb Slope | 5.8 |
| No | Gutter Run Slope (%) | 5.8 | | Road Cross Slope (%) | N/A |

Remove & Replace Entire Ramp. Remove & Replace Gutter.

R304.2.2, R304.2.1, R304.5.4, STD 1115
