# Access Compliance Report Public Rights-of-Way (Curb Ramps)

Main Street: SILVERWOOD\_DR Cross Street: MARTHA\_ANN\_DR Location: S

ADA ID: RPAT211201105721 Ramp Type: Type 1 - Perpendicular Diagonal Initial Pass/Fail: Pass Overall Compliance: No Severity Score: 20

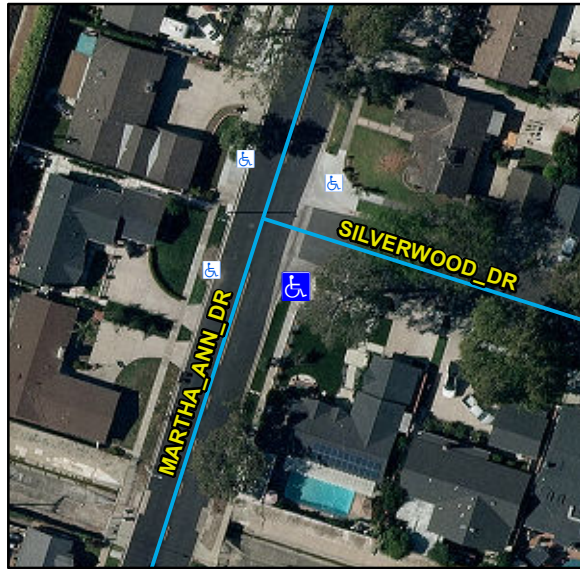
| Compliance | Description | Data | Compliance | Description | Data |
|---|---|---|---|---|---|
| No | Landing Run Slope (%) | 2.8 | N/A | Flare Traversable RT | Yes |
| No | Landing Cross Slope (%) | 3.4 | No | DWS Provided | No |
| Yes | Gutter Ponding | No | No | Curb Slope | 8.3 |
| No | Gutter Run Slope (%) | 6.4 | | Road Cross Slope (%) | 0.2 |

Remove & Replace Curb Ramp With Two New Directional Ramps or Equivalent. Remove & Replace Gutter.
