# Access Compliance Report Public Rights-of-Way (Curb Ramps)

Main Street: SILVERWOOD\_DR Cross Street: KENSINGTON\_RD Location: N

ADA ID: RPAT211201110437 Ramp Type: Type 1 - Perpendicular Diagonal Initial Pass/Fail: Pass Overall Compliance: No Severity Score: 14

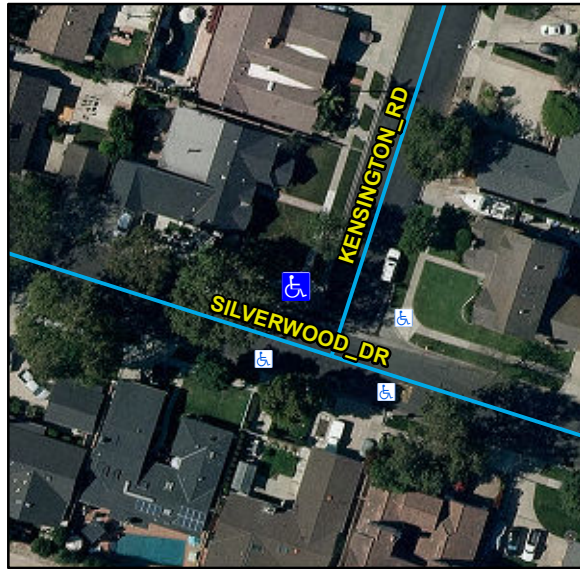
| Compliance | Description | Data | Compliance | Description | Data |
|---|---|---|---|---|---|
| No | Landing Run Slope (%) | 3.1 | N/A | Flare Traversable RT | No |
| Yes | Landing Cross Slope (%) | 0.2 | No | DWS Provided | No |

Remove & Replace Curb Ramp With Two New Directional Ramps or Equivalent.
