# Access Compliance Report Public Rights-of-Way (Curb Ramps)

| Main Street: KENSINGTON_RD | | Cross Street: SILVERWOOD_DR | | Location: | E |
| ADA ID: RPAT211201110904 | Ramp Type:Type 1 - Perpendicular Diagonal Initial Pass/Fail: Fail | | Overall Compliance: No | Severity Score: | 15 |

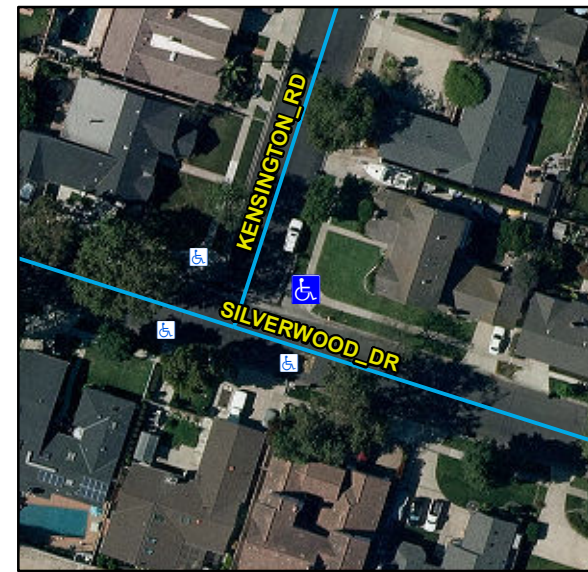
| Compliance | Description | Data | Compliance | Description | Data |
|---|---|---|---|---|---|
| No | Ramp Run Slope (%) | 8.4 | N/A | Flare Slope LT (%) | N/A |

**Remove & Replace Curb Ramp With Two New Directional Ramps or Equivalent.**

**R304.2.2, STD 1115**
