# Access Compliance Report Public Rights-of-Way (Curb Ramps)

Main Street: WEMBLEY\_RD Cross Street: SILVERWOOD\_DR Location: E

ADA ID: RPAT211201112033 Ramp Type: Type 1 - Perpendicular Diagonal Initial Pass/Fail: Pass Overall Compliance: No Severity Score: 18

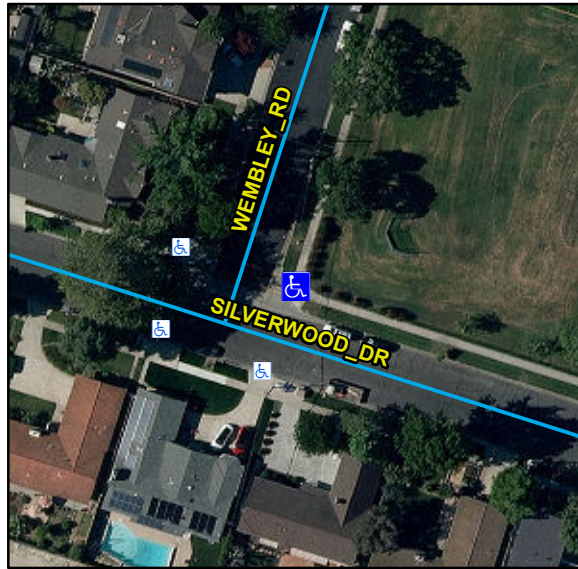
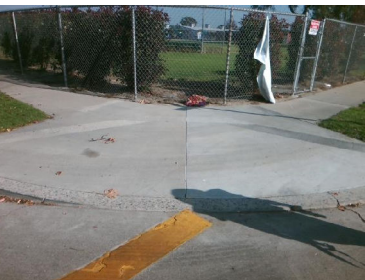
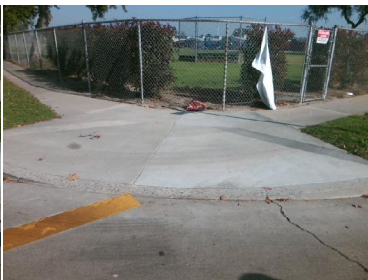
| Compliance | Description | Data | Compliance | Description | Data |
|---|---|---|---|---|---|
| Yes | Landing Cross Slope (%) | 0 | No | DWS Provided | No |
| N/A | Landing Movement Obstructed? | Yes | N/A | DWS Contrast | N/A |
| | Landing Movement Type | Fence | N/A | DWS Length (in) | N/A |

Remove & Replace Curb Ramp With Two New Directional Ramps or Equivalent.

R204.3, R304.2.1, R305, STD 1115
