# Access Compliance Report Public Rights-of-Way (Curb Ramps)

Main Street: SILVERWOOD\_DR Cross Street: WEMBLEY\_RD Location: W

ADA ID: RPAT211201112553 Ramp Type: Type 1 - Perpendicular Initial Pass/Fail: Pass Overall Compliance: No Severity Score: 16

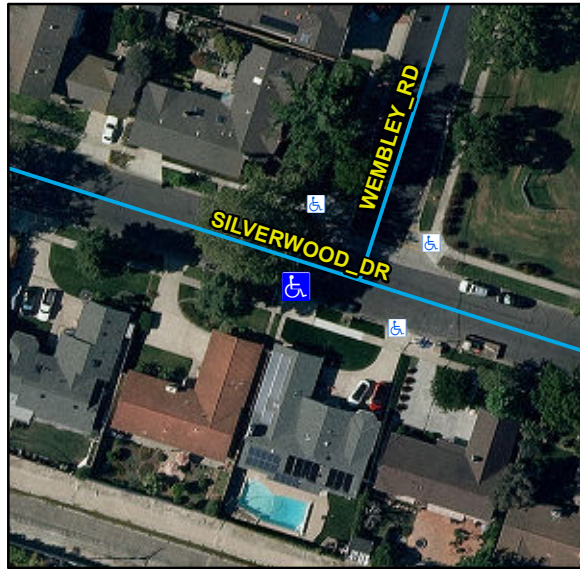
| Compliance | Description | Data | Compliance | Description | Data |
|---|---|---|---|---|---|
| No | Landing Run Slope (%) | 2.7 | N/A | Flare Traversable RT | No |
| Yes | Landing Cross Slope (%) | 2.4 | No | DWS Provided | No |
| No | Gutter Ponding | Yes | No | Curb Slope | 6 |
| No | Gutter Run Slope (%) | 5.1 | | Road Cross Slope (%) | N/A |

Remove & Replace Entire Ramp. Remove & Replace Gutter.
