# Access Compliance Report Public Rights-of-Way (Curb Ramps)

Main Street: FOSTER\_RD Cross Street: KITTRICK\_DR Location: SE

ADA ID: RPAT211202085201 Ramp Type: Type 1 - Perpendicular Diagonal Initial Pass/Fail: Fail Overall Compliance: No Severity Score: 4

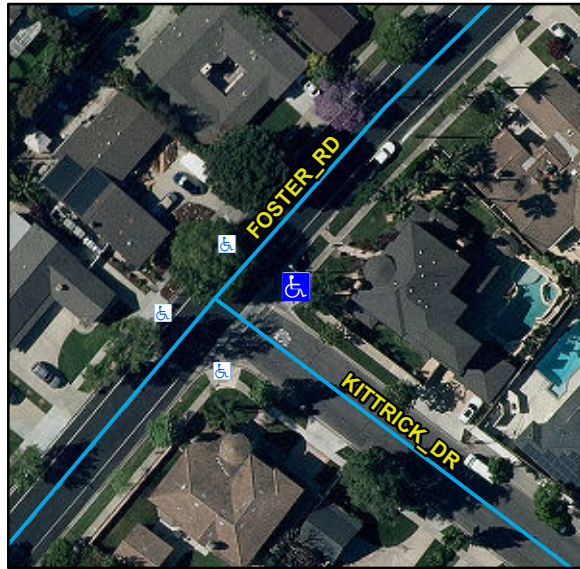
| Compliance | Description | Data | Compliance | Description | Data |
|---|---|---|---|---|---|
| No | Ramp Width (in) | 39 | | | N/A |

Remove & Replace Curb Ramp With Two New Directional Ramps or Equivalent.
