# Access Compliance Report Public Rights-of-Way (Curb Ramps)

Main Street: KITTRICK\_DR Cross Street: FOSTER\_RD Location: S

ADA ID: RPAT211202085448 Ramp Type: Type 1 - Perpendicular Diagonal Initial Pass/Fail: Fail Overall Compliance: No Severity Score: 16

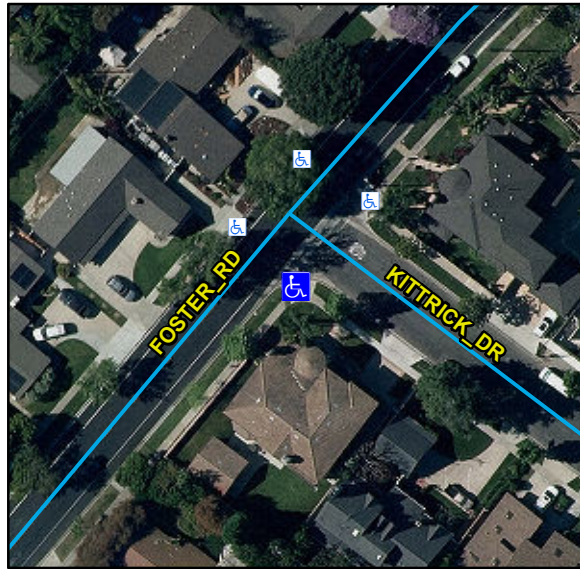
R304.2.2, R204.3, R304.5.3, STD 1115

| Compliance | Description | Data | Compliance | Description | Data |
|---|---|---|---|---|---|
| No | Ramp Run Slope (%) | 9 | N/A | Flare Slope LT (%) | N/A |
| No | Ramp Cross Slope (%) | 2.8 | N/A | Flare Traversable LT | N/A |

Remove & Replace Curb Ramp With Two New Directional Ramps or Equivalent.
