# Access Compliance Report Public Rights-of-Way (Curb Ramps)

Main Street: KITTRICK\_DR Cross Street: DONOVAN\_RD Location: N

ADA ID: RPAT211202085924 Ramp Type: Type 1 - Perpendicular Diagonal Initial Pass/Fail: Fail Overall Compliance: No Severity Score: 2

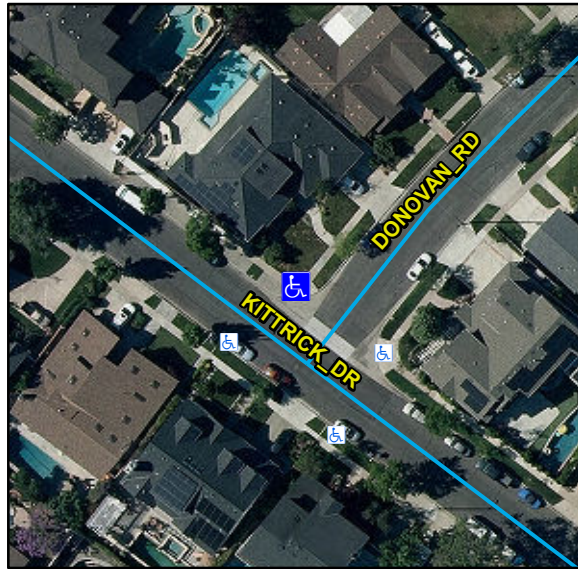
| Compliance | Description | Data | Compliance | Description | Data |
|---|---|---|---|---|---|
| No | Ramp Cross Slope (%) | 2.7 | N/A | Flare Traversable LT | N/A |
| Yes | Overall Surface Condition: Acceptable | | No | Perp Joint Present | No |

Remove & Replace Curb Ramp With Two New Directional Ramps or Equivalent.
