# Access Compliance Report Public Rights-of-Way (Curb Ramps)

Main Street: DONOVAN\_RD Cross Street: KITTRICK\_DR Location: E

ADA ID: RPAT211202090135 Ramp Type: Type 1 - Perpendicular Diagonal Initial Pass/Fail: Pass Overall Compliance: No Severity Score: 18

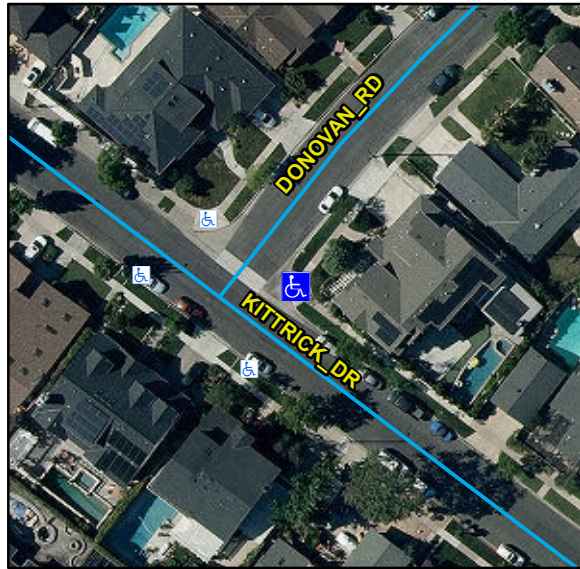
| Compliance | Description | Data | Compliance | Description | Data |
|---|---|---|---|---|---|
| N/A | Ramp Length (in) | 85 | N/A | Flare Type LT | |
| Yes | Ramp Width (in) | 53 | | | Sloped |
| Yes | Ramp Run Slope (%) | 7.3 | N/A | Flare Slope LT (%) | 6 |
| Yes | Ramp Cross Slope (%) | 1.1 | N/A | Flare Traversable LT | No |
| No | Landing Run Slope (%) | 2.7 | N/A | Flare Traversable RT | No |
| Yes | Landing Cross Slope (%) | 1.7 | No | DWS Provided | No |
| Yes | Gutter Ponding | No | No | Curb Slope | 7 |
| No | Gutter Cross Slope (%) | 2.1 | | | |

Remove & Replace Curb Ramp With Two New Directional Ramps or Equivalent. Remove & Replace Gutter.
