# Access Compliance Report Public Rights-of-Way (Curb Ramps)

| Main Street: BASKERVILLE_RD | | Cross Street: KITTRICK_DR | | Location: | E |
| ADA ID: RPAT211202090943 | Ramp Type:Type 1 - Perpendicular Diagonal Initial Pass/Fail: Fail | | Overall Compliance: No | Severity Score: | 15 |

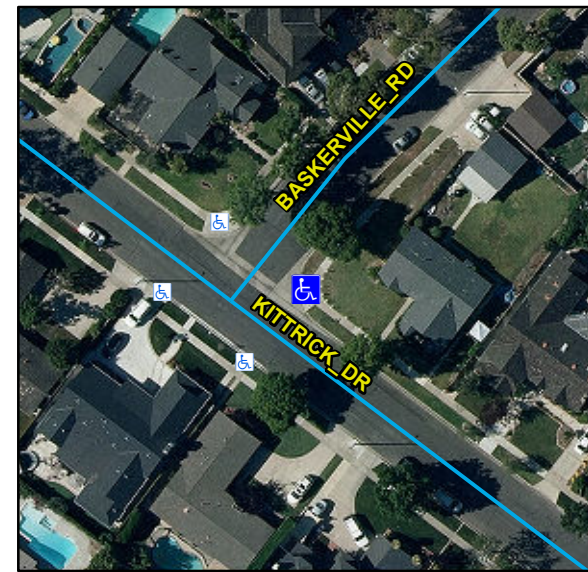
| Compliance | Description | Data | Compliance | Description | Data |
|---|---|---|---|---|---|
| No | Ramp Run Slope (%) | 9.3 | N/A | Flare Slope LT (%) | N/A |

Remove & Replace Curb Ramp With Two New Directional Ramps or Equivalent.

R204.3, R304.2.2, STD 1115

Total Cost: \$ 6160
