# Access Compliance Report Public Rights-of-Way (Curb Ramps)

Main Street: KITTRICK\_DR Cross Street: HARRISBURG\_RD Location: N

ADA ID: RPAT211202091447 Ramp Type: Type 1 - Perpendicular Diagonal Initial Pass/Fail: Fail Overall Compliance: No Severity Score: 2

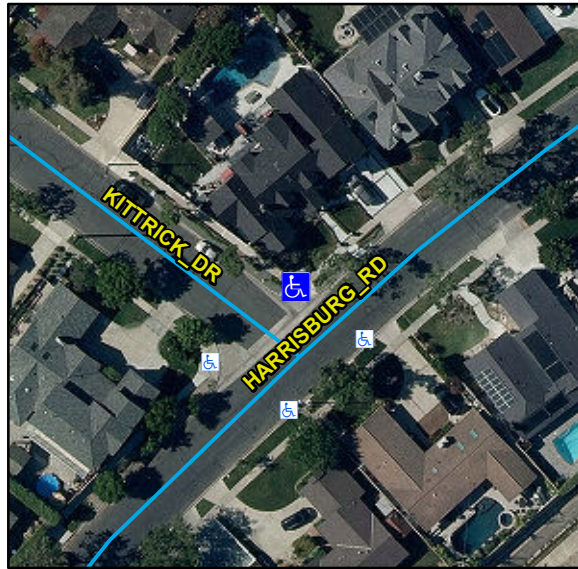
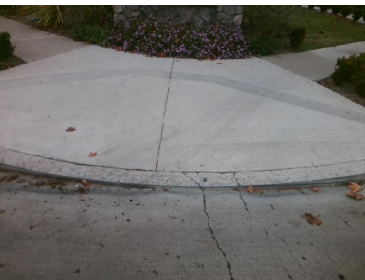
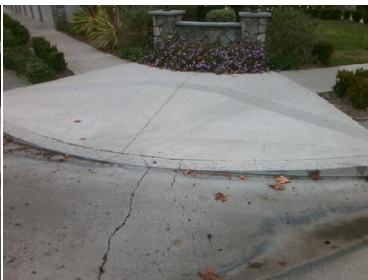
| Compliance | Description | Data | Compliance | Description | Data |
|---|---|---|---|---|---|
| No | Ramp Cross Slope (%) | 2.3 | N/A | Flare Traversable LT | N/A |
| N/A | Gutter Ponding | N/A | No | Curb Slope | 5.6 |

Remove & Replace Curb Ramp With Two New Directional Ramps or Equivalent.

R304.2.2, R204.3, R304.5.3, STD 1115
