# Access Compliance Report Public Rights-of-Way (Curb Ramps)

Main Street: HARRISBURG\_RD Cross Street: KITTRICK\_DR Location: W

ADA ID: RPAT211202091930 Ramp Type: Type 1 - Perpendicular Diagonal Initial Pass/Fail: Fail Overall Compliance: No Severity Score: 15

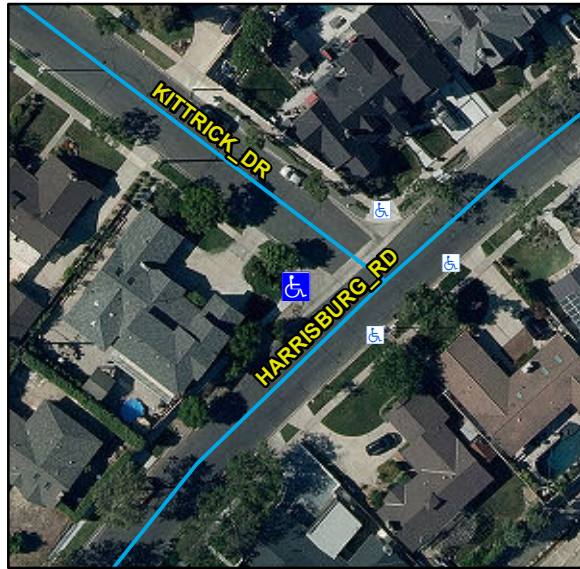
| Compliance | Description | Data | Compliance | Description | Data |
|---|---|---|---|---|---|
| No | Ramp Run Slope (%) | 9.1 | N/A | Flare Slope LT (%) | N/A |

Remove & Replace Curb Ramp With Two New Directional Ramps or Equivalent.

R304.2.2, R204.3, STD 1115
