# Access Compliance Report Public Rights-of-Way (Curb Ramps)

Main Street: SHAKESPEARE\_DR Cross Street: HARRISBURG\_RD Location: N

ADA ID: RPAT211202092432 Ramp Type: Type 1 - Perpendicular Diagonal Initial Pass/Fail: Pass Overall Compliance: No Severity Score: 0

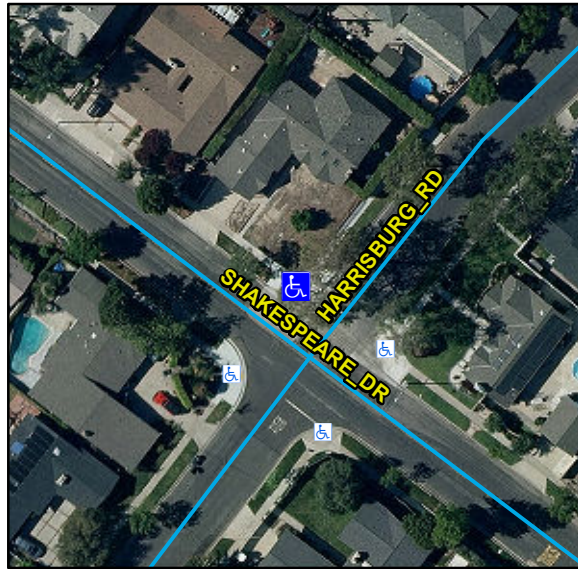
| Compliance | Description | Data | Compliance | Description | Data |
|---|---|---|---|---|---|
| No | Landing Run Slope (%) | 2.2 | N/A | Flare Traversable RT | No |
| No | Landing Cross Slope (%) | 2.1 | Yes | DWS Provided | Yes |

Remove & Replace Landing.
