# Access Compliance Report Public Rights-of-Way (Curb Ramps)

| Main Street: HARRISBURG_RD | | Cross Street: SHAKESPEARE_DR | | Location: | E |
| ADA ID: RPAT211202092848 | Ramp Type:Type 1 - Perpendicular Diagonal Initial Pass/Fail: Fail | | Overall Compliance: No | Severity Score: | 15 |

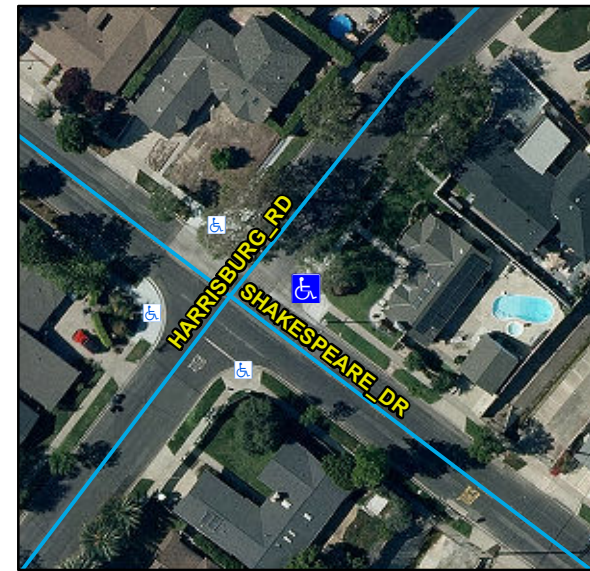
| Compliance | Description | Data | Compliance | Description | Data |
|---|---|---|---|---|---|
| No | Ramp Run Slope (%) | 8.9 | N/A | Flare Slope LT (%) | N/A |

**Remove & Replace Curb Ramp With Two New Directional Ramps or Equivalent.**

**R304.2.2, STD 1115**

Total Cost: \$ 6160
