# Access Compliance Report Public Rights-of-Way (Curb Ramps)

Main Street: SHAKESPEARE\_DR Cross Street: HARRISBURG\_RD Location: NE

ADA ID: RPAT211202093131 Ramp Type: Type 1 - Perpendicular Diagonal Initial Pass/Fail: Pass Overall Compliance: No Severity Score: 22

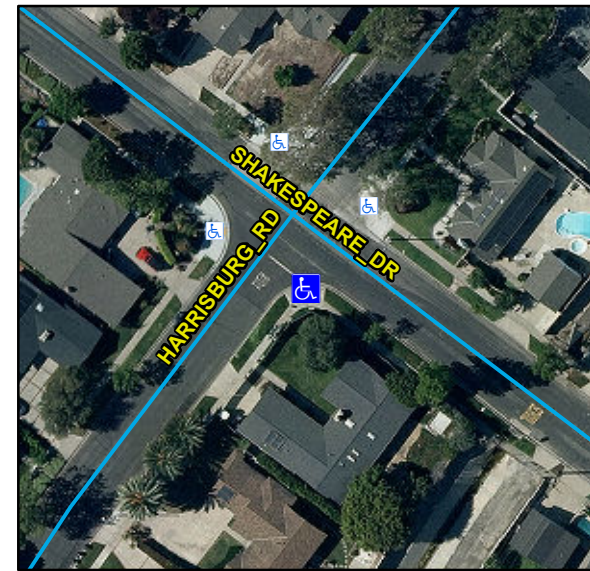
| Compliance | Description | Data | Compliance | Description | Data |
|---|---|---|---|---|---|
| No | Landing Cross Slope (%) | 2.3 | No | DWS Provided | No |
| Yes | Gutter Ponding | No | No | Curb Slope | 67 |
| No | Gutter Run Slope (%) | 9.1 | | Road Cross Slope (%) | 2.9 |

**Remove & Replace Curb Ramp With Two New Directional Ramps or Equivalent. Remove & Replace Gutter.**

**R304.2.2, R204.3, R304.2.1, R304.5.3, R305, R304.5.4, STD 1115**
