# Access Compliance Report Public Rights-of-Way (Curb Ramps)

Main Street: HARRISBURG\_RD Cross Street: SHAKESPEARE\_DR Location: W

ADA ID: RPAT211202093459 Ramp Type: Type 1 - Perpendicular Diagonal Initial Pass/Fail: Pass Overall Compliance: No Severity Score: 5

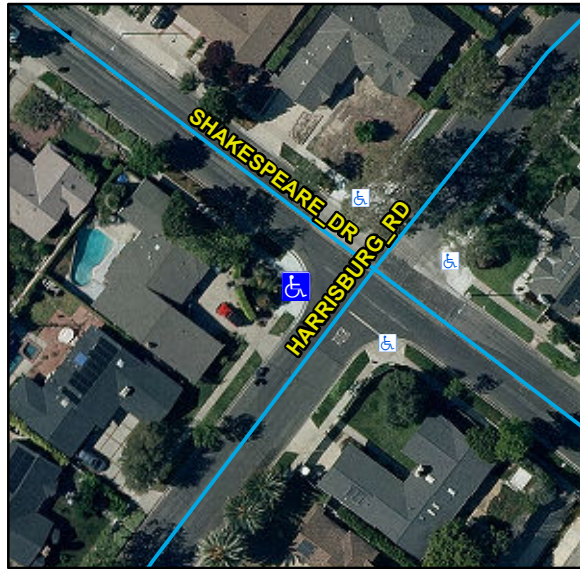
| Compliance | Description | Data | Compliance | Description | Data |
|---|---|---|---|---|---|
| No | Gutter Run Slope (%) | 6.8 | | Road Cross Slope (%) | 3 |

Remove & Replace Gutter.

R304.5.4, STD 1115
