# Access Compliance Report Public Rights-of-Way (Curb Ramps)

Main Street: SHAKESPEARE\_DR Cross Street: BASKERVILLE\_RD Location: S

ADA ID: RPAT211202094100 Ramp Type: Type 1 - Perpendicular Diagonal Initial Pass/Fail: Pass Overall Compliance: No Severity Score: 21

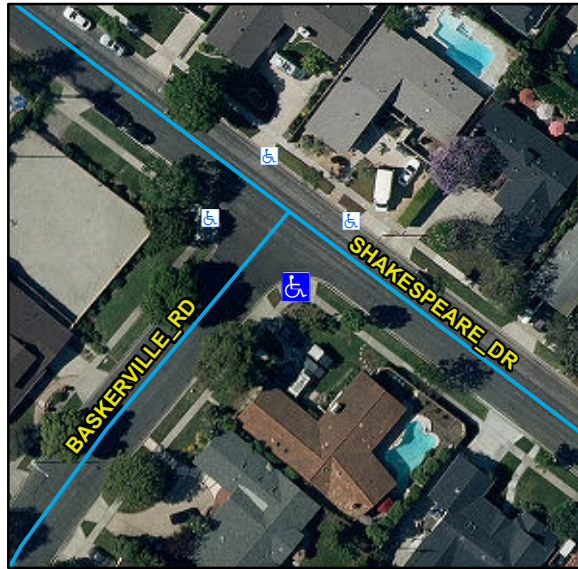
| Compliance | Description | Data | Compliance | Description | Data |
|---|---|---|---|---|---|
| Yes | Landing Cross Slope (%) | 0.5 | No | DWS Provided | No |
| No | Gutter Run Slope (%) | 10.5 | | Road Cross Slope (%) | 2.9 |

**Remove & Replace Curb Ramp With Two New Directional Ramps or Equivalent. Remove & Replace Gutter.**

**R204.3, R304.2.1, R305, R304.5.4, STD 1115**
