# Access Compliance Report Public Rights-of-Way (Curb Ramps)

Main Street: BASKERVILLE\_RD Cross Street: SHAKESPEARE\_DR Location: W

ADA ID: RPAT211202094518 Ramp Type: Type 1 - Perpendicular Diagonal Initial Pass/Fail: Fail Overall Compliance: No Severity Score: 16

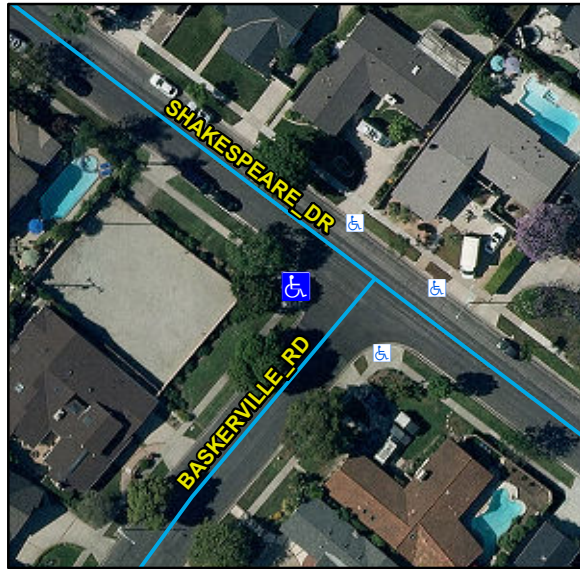
| Compliance | Description | Data | Compliance | Description | Data |
|---|---|---|---|---|---|
| No | Ramp Run Slope (%) | 9.4 | N/A | Flare Slope LT (%) | N/A |

Remove & Replace Curb Ramp With Two New Directional Ramps or Equivalent.
