# Access Compliance Report Public Rights-of-Way (Curb Ramps)

Main Street: SHAKESPEARE\_DR Cross Street: DONOVAN\_RD Location: S

ADA ID: RPAT211202094901 Ramp Type: Type 1 - Perpendicular Diagonal Initial Pass/Fail: Pass Overall Compliance: No Severity Score: 21

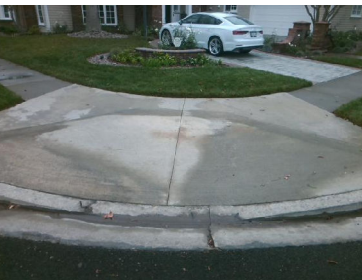
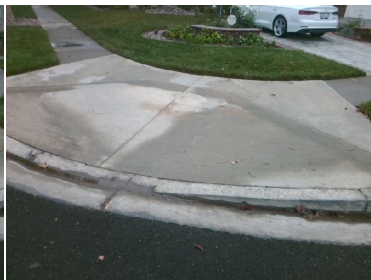
| Compliance | Description | Data | Compliance | Description | Data |
|---|---|---|---|---|---|
| Yes | Landing Cross Slope (%) | 1.4 | No | DWS Provided | No |
| Yes | Gutter Ponding | No | No | Curb Slope | 8.7 |
| No | Gutter Run Slope (%) | 7.2 | | Road Cross Slope (%) | 3.4 |

Remove & Replace Curb Ramp With Two New Directional Ramps or Equivalent. Remove & Replace Gutter.
