# Access Compliance Report Public Rights-of-Way (Curb Ramps)

Main Street: DONOVAN\_RD Cross Street: SHAKESPEARE\_DR Location: W

ADA ID: RPAT211202095309 Ramp Type: Type 1 - Perpendicular Diagonal Initial Pass/Fail: Fail Overall Compliance: No Severity Score: 2

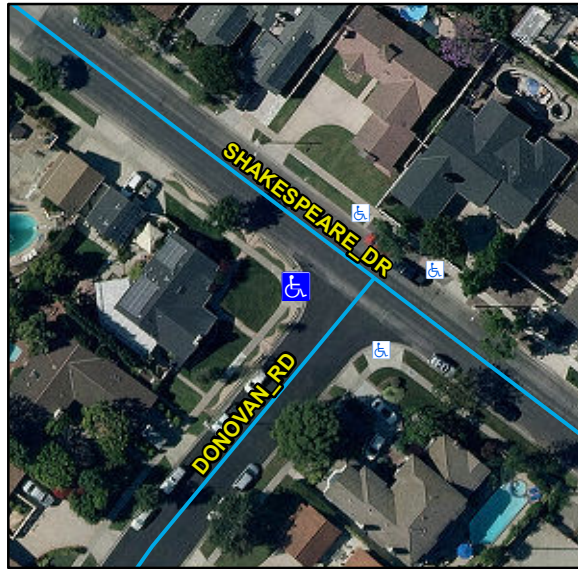
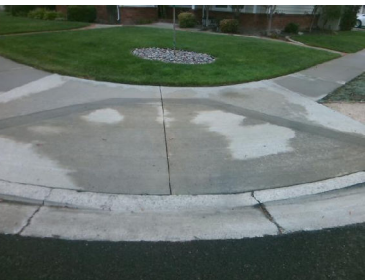
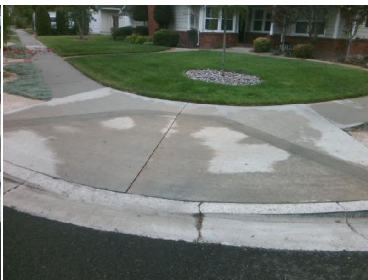
| Compliance | Description | Data | Compliance | Description | Data |
|---|---|---|---|---|---|
| No | Ramp Cross Slope (%) | 2.9 | N/A | Flare Traversable LT | N/A |
| N/A | Gutter Ponding | N/A | No | Curb Slope | 8.8 |

Remove & Replace Curb Ramp With Two New Directional Ramps or Equivalent.

R304.2.2, R204.3, R304.5.3, STD 1115
