# Access Compliance Report Public Rights-of-Way (Curb Ramps)

Main Street: SHAKESPEARE\_DR Cross Street: FOSTER\_RD Location: S

ADA ID: RPAT211202095607 Ramp Type: Type 1 - Perpendicular Diagonal Initial Pass/Fail: Fail Overall Compliance: No Severity Score: 15

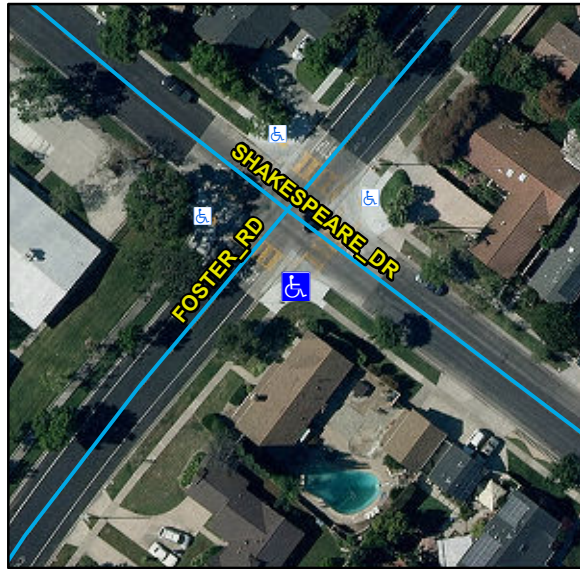
| Compliance | Description | Data | Compliance | Description | Data |
|---|---|---|---|---|---|
| No | Ramp Run Slope (%) | 8.7 | N/A | Flare Slope LT (%) | N/A |

Remove & Replace Curb Ramp With Two New Directional Ramps or Equivalent.

R304.2.2, STD 1115
