# Access Compliance Report

## Public Rights-of-Way

### (Curb Ramps)

Main Street: FOSTER\_RD Cross Street: SHAKESPEARE\_DR Location: W

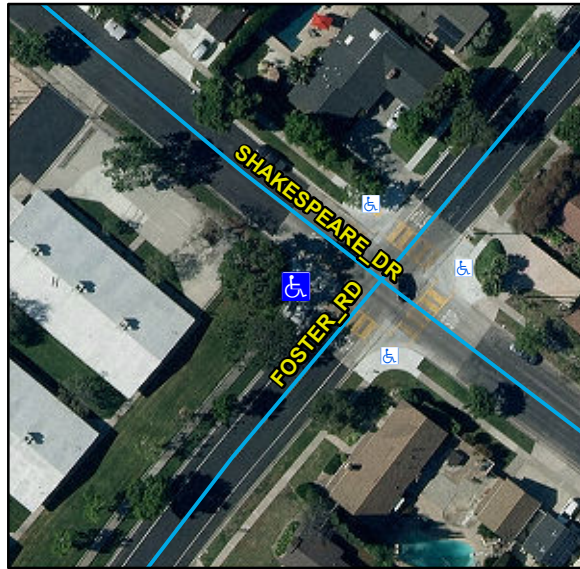
ADA ID: RPAT211202115102 Ramp Type: Type 1 - Perpendicular Diagonal Initial Pass/Fail: Fail Overall Compliance: No Severity Score: 15

| Compliance | Description | Data | Compliance | Description | Data |
|---|---|---|---|---|---|
| No | Ramp Run Slope (%) | 9.5 | N/A | Flare Slope LT (%) | N/A |

**Remove & Replace Curb Ramp With Two New Directional Ramps or Equivalent.**

**R304.2.2, STD 1115**

Total Cost: \$ 6160
